**Bulletin BPI 12-01**

**Subject:** Importance of On-Vehicle Brake Lathe Use

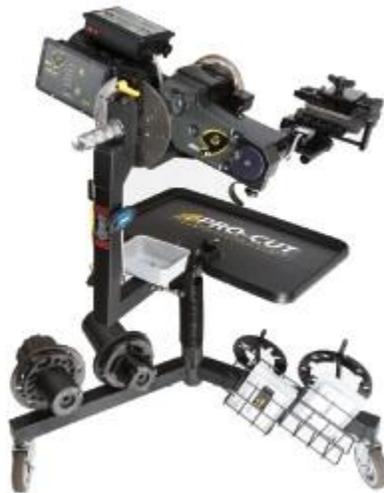
OEMs have ample resources for identifying problems and providing solutions for their customers' satisfaction. Recent Technical Service Bulletins provided by Honda, Hyundai, Mazda, and Volkswagen address the issue of brake pulsation and stress the use of the on-vehicle brake lathe **exclusively** for rotor resurfacing. They no longer recommend **any** off-vehicle rotor machining.

The reason for this is to account for the runout in the rotor, hub flange, wheel bearings and the surface condition of the mating surfaces of the hub flange and rotor. The goal is to achieve .002" lateral runout or less, as installed on the vehicle.

As with all brake work, inspection of the rotors for cracks, severe discoloration or corrosion, and measurement of the thickness of the rotor should be performed. This is to ensure the rotors are serviceable before proceeding. After inspection, careful cleaning of the mating surfaces with the proper surface-conditioning discs and tools is important before machining operations are begun.

Follow the lathe manufacturer's instructions for setup and machining operation. Also important is to maintain the cutting tools as recommended to ensure the quality of the finish that is produced by the lathe.

After machining, clean the surface with hot, soapy water and a brush to remove any loose machining grit. Before removing the lathe hub adapter from the rotor, measure the thickness of the disc to ensure it is still above minimum thickness and recheck the lateral runout to see that it is within the .002" specification.
