Stop The 'Warped' Rotors Myth And Service Brakes The Right Way

Technical Talk by Chris Crowell - Dec 9, 2015

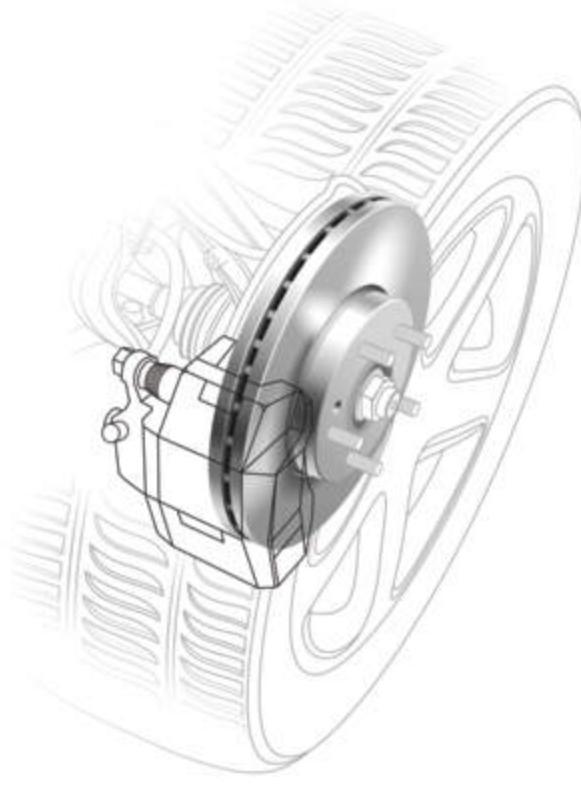
Lateral runout

Runout is a measurement of the difference between the high and low spots in the hub and on the rotor.

On each revolution of the wheel, as the high spot of the rotor scrapes unevenly with the hub or applies friction unevenly with the pad, the results for the rotor's face are just that — uneven.

Root causes of runout include:

- Runout from the hub mounting face;
- Runout from the wheel bearing;
- Sloppy resurfacing/machining procedures;
- A buildup of rust and corrosion between the rotor, hub and wheel;
- Uneven torque on the lug nuts;
- Wheel loading distortions; and
- Variations in manufacturing tolerances.

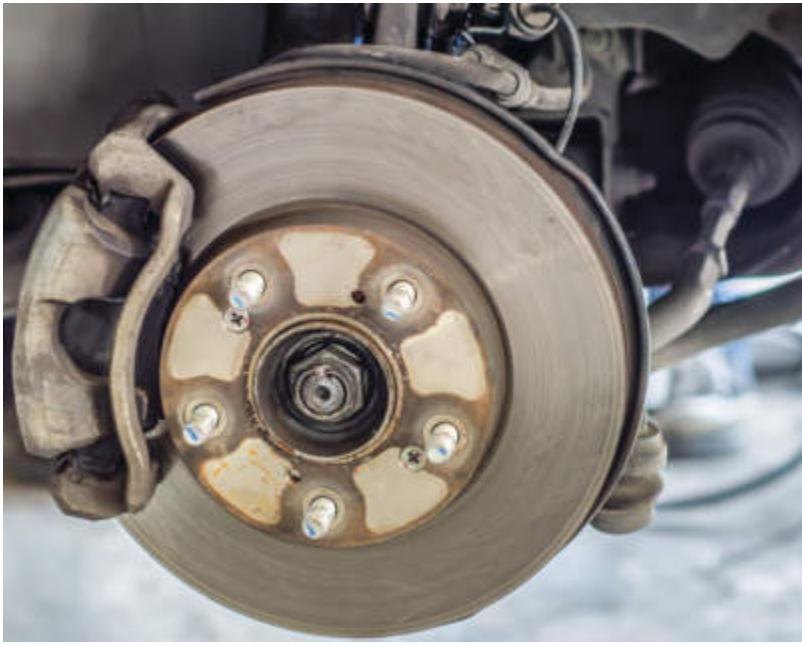
Disc Thickness Variation

This is the real culprit behind most of your "warped rotor" claims. A normal braking event requires a brake pad to be applied squarely against the rotor. Each time this happens, a tiny layer of friction is removed from the pad and is deposited on the face of the rotor.

A rotor with runout beyond the specs cannot receive that even application of friction, which means it starts to receive an uneven deposit of friction on its surface. Disc thickness variation is just that — the rotor is now thicker in some spots thanks to the extra layers of friction, which all started because of lateral runout. The DTV is the thickest area minus the thinnest area of the rotor.

The thickness variation is subtle, but all of these details add up. When the thick part of the rotor is forcing itself through the caliper, the torque of the brake and the pressure in the caliper rise. When the thin spot passes through, the torque drops and pressure drops. Very small amounts of DTV can create a significant problem. More late-model vehicles are built with a thickness variation of less than 0.00078". Thickness variations in excess of 15 microns (0.00059") can easily generate driver complaints.

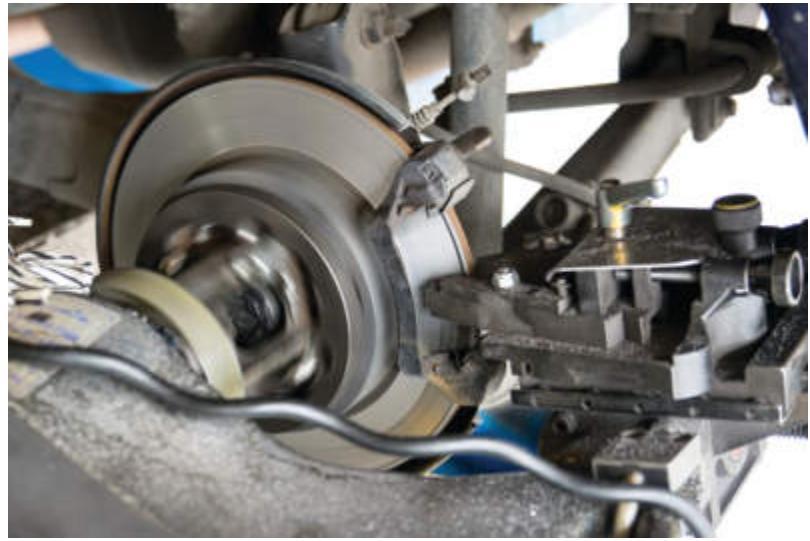
Cold brake roughness manifests in a similar feel of pedal pulsation or steering wheel vibration, and in severe cases, there will be speed-related surges in deceleration felt during normal driving and light braking. This phenomenon is caused by lateral runout that exists when the rotors are initially mounted on the car. Over time, this gradually turns into disc thickness variation due to inconsistencies in the lining only touching the higher spots of the rotor during off-brake driving.
